# Durability of retro-reflecting materials for road signs

Nordic field test; test signs 1996->

Research reports of the Finnish Transport Agency  
50eng/2016

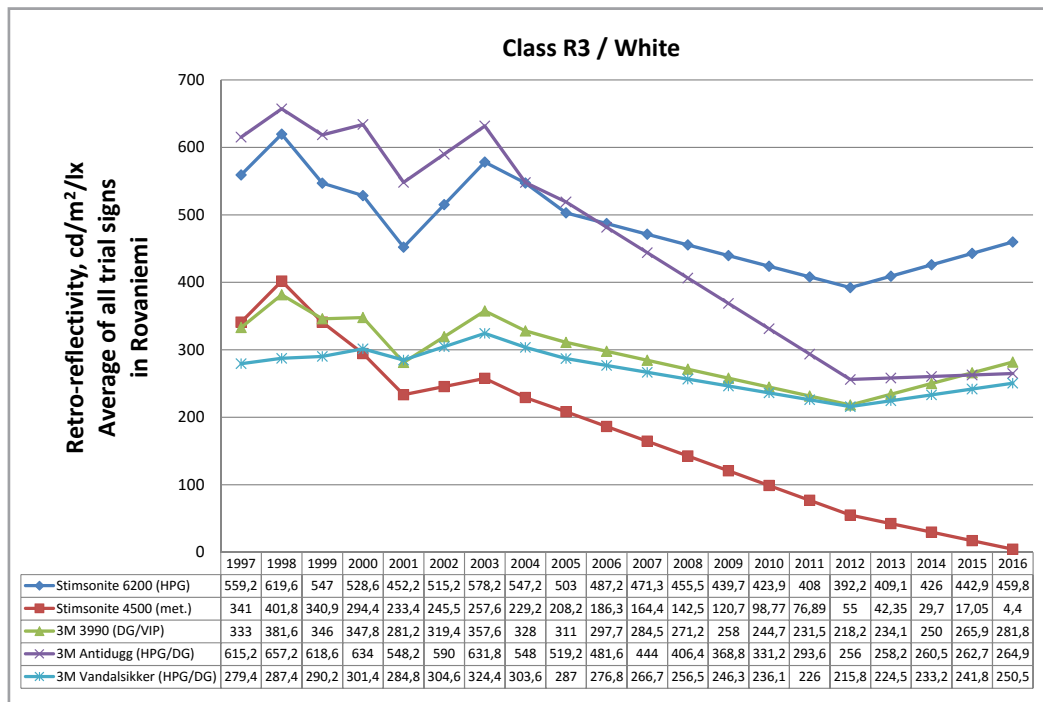
Figure 13. An example of the change in the average of retro-reflectivity from all the trial signs in Rovaniemi regarding some white materials after 19 years of aging.

The following figure (Figure 13) is an example of the change in the retro-reflectivity average of all the signs in Rovaniemi regarding some white materials. It should be noted that there is apparently a systematic error in the values from year 2012, which lowers the value of apparently 10 to 20%. The reason is unknown. The curve variations from the early years may also include similar errors, or else there has been a difference in cleaning technology.

The lowest curve represents the development of a completely damaged material towards result in year 2016 which seems to have not attributed to any external reason, but has been systematic and continuous.

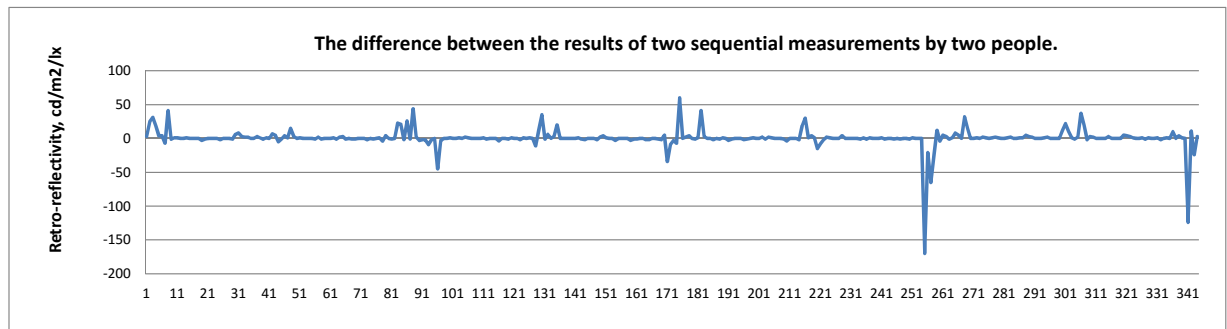
Figure 14. The difference between the results of two measurements of different people.

When two people measured the same materials ostensibly in the same manner, it was obtained, in the worst case, up to 170 cd / lx / m<sup>2</sup> difference (99 vs. 269). There were several other smaller but significant differences in the measurement (fig. 14). On closer inspection, it turned out that all the measurements with major differences were from so-called micro-prismatic materials. Apparently, the light reflected from these materials varied considerably in a small area or between different position angles of the meter handle. Since it was not a well-known phenomenon, in spite of the differences between the measurements the value was taken as the average of these two measurements.

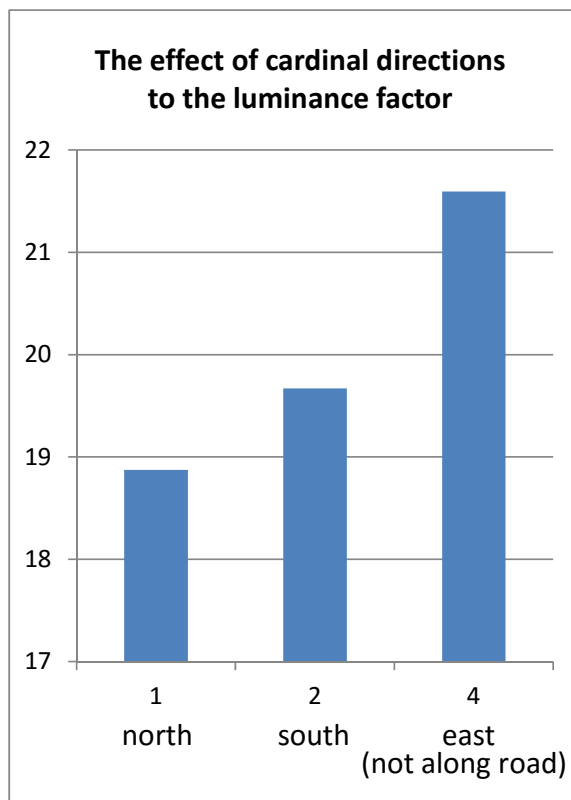
Figure 18. The effect of cardinal directions to the luminance factor

The luminance factor could be expected to change more in materials towards the sun than the ones facing north. This does not, however, appear on the averages (Figure 18): the materials along the road were just a little bit darker facing north than facing south. Both of them had faded to some degree when they are validated against the reference sign materials.

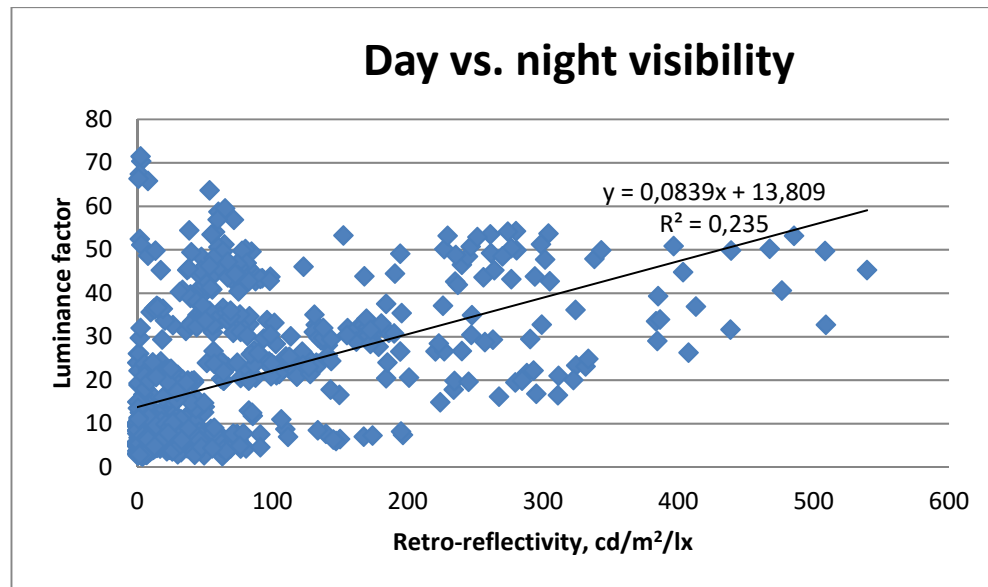
Figure 19. The dependence of day visibility on night visibility (all materials after 19 years).

Especially white materials in rows 2, 5, 11 and 14 did not meet the requirement. They were in all trial signs after 19 years below the minimum requirement limit of 0.35. Nevertheless, it's worth mentioning that materials in rows 11 and 14 still did retro-reflect very well.

In other words, the deterioration of the day visibility does not necessarily lead to the deterioration of the night visibility (see figure 19). The white materials in row 7 were especially bright when measured in this geometry, even if they are far from the whitest in diffuse light as can be seen from the pictures (Figure 12). This may be an indication of the lack of the ability of the measurement methods used for this purpose to simulate all possible lighting conditions.

The dependence of day visibility on night visibility is not very clear (see. Figure 19). This is particularly striking regarding materials in row 1, which reflect well (see. Cover art), but do not during the day seem especially white (see. Figure 12).

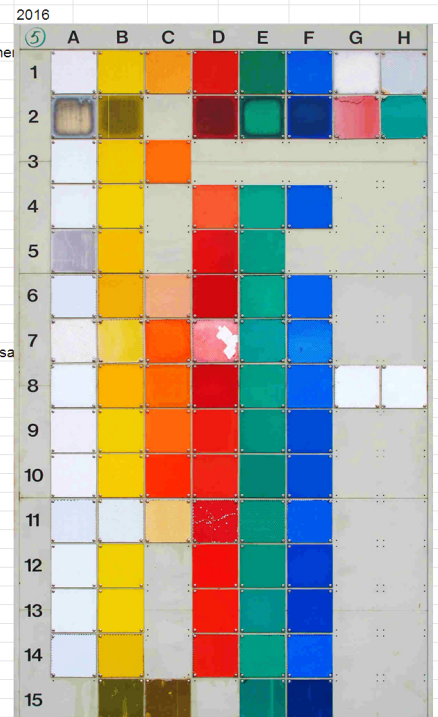
Very strange wear on Sign 5 sheet 8H (four worn patces very regularly spaced, not from measuring)
